NEWSLETTER

Issue 35 March 2009

· INSTITUTE · OF · HISTORIC ·
BUILDING · CONSERVATION

WEST MIDLANDS BRANCH

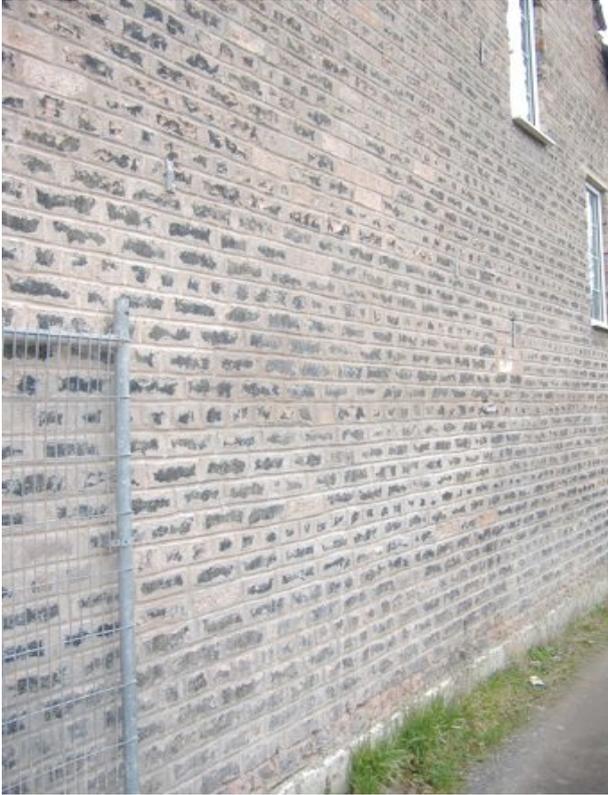
Ooh! How NOT to repoint a C19 wall. Seen in Kidderminster this February.

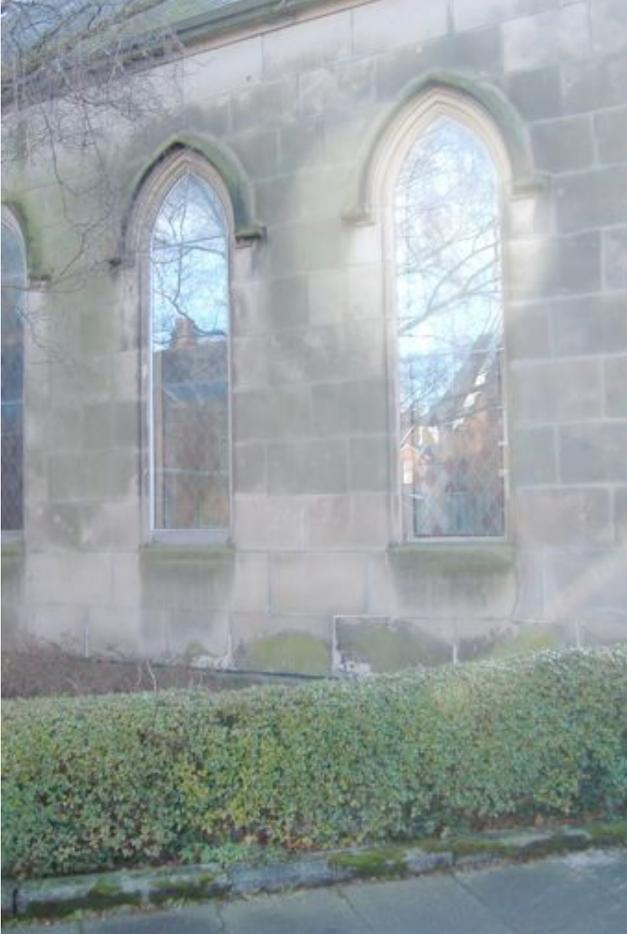
That polycarbonate security glazing at St George's Church

St George's Church featured external secondary glazing that looked almost brand new. Nothing to do with energy conservation, but installed to protect the original leaded glass from missiles. Not a good idea, as one walkabout participant pointed-out. Such security glazing can trap moisture in the air sandwich between the two windows. This moisture in turn leads to corrosion of lead cames. The security glazing needs to be drilled for ventilation purposes.

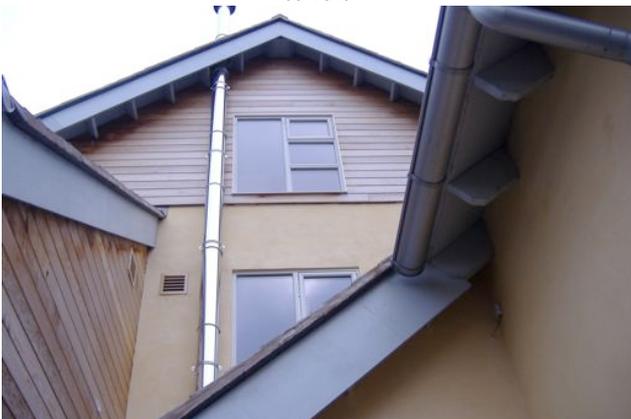
Pump House extension – detail at rear

Whilst the glazing framing looks like UPVC it is actually locally-sourced softwood with a paint finish. The new wing, which is timber-framed, is clad in a mixture of soft lime render and natural finish close-boarding. Rainwater goods are galvanized sheet metal sourced from Sweden.

The converted Pump House is intended to be a 'showcase' example of sustainable design. Stylistically, the cream and grey new extension, with its gables, does not complement the original Edwardian orange brick and the bays into which it is formed by wall piers. There was a slip-up in the detailing as the corner adjoining the car park lacks any kind of protective bollard, with the result that the render and downpipe have suffered vehicle impact. A nice touch was that one of the few vehicles in the car park was signwritten to announce that it ran on rape seed oil!

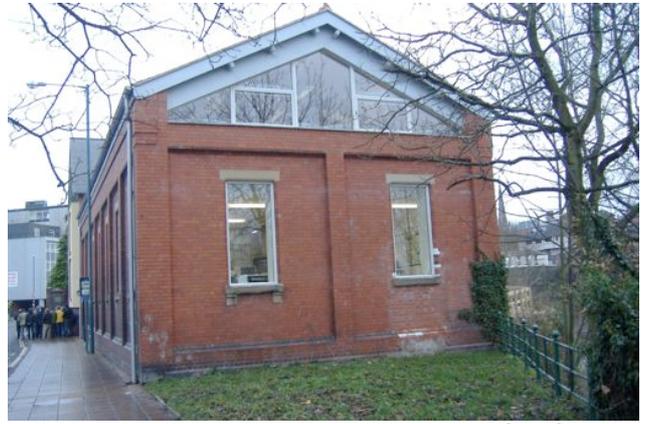
Pump House end gable, showing new first floor accommodation

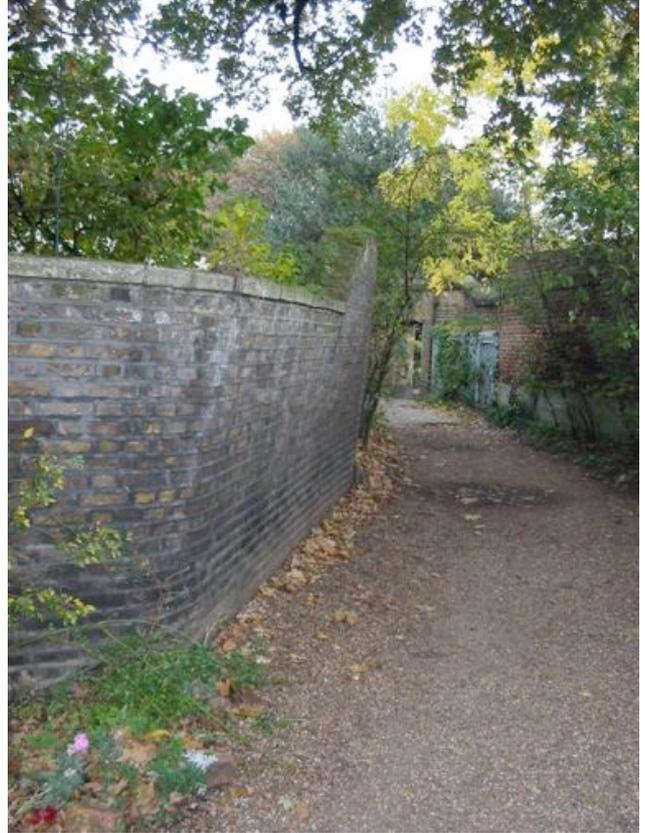
Monitoring

There are many measuring devices that can record movement. A cracked glass tell-tale is no use in the analysis of direction or rate of movement often not sticking properly to the substrate. SPAB & BRE pamphlets describe some of the better devices, but to these can be added strain gauges or vernier callipers are the most useful and discrete crack measuring devices. The targets required are brass screws or small discs less than 5mm. diameter. They can be placed on the structure with minimal damage, and are unobtrusive when not in use.

Many times we are called upon to reach rapid conclusions as to the stability of a structure mostly for political reasons. Cracks are often only reported when they 'appear to be getting worse', but often the complainant cannot say definitely, or more importantly which way. Any structural movement has to be established and in what direction, before any repairs suggested.

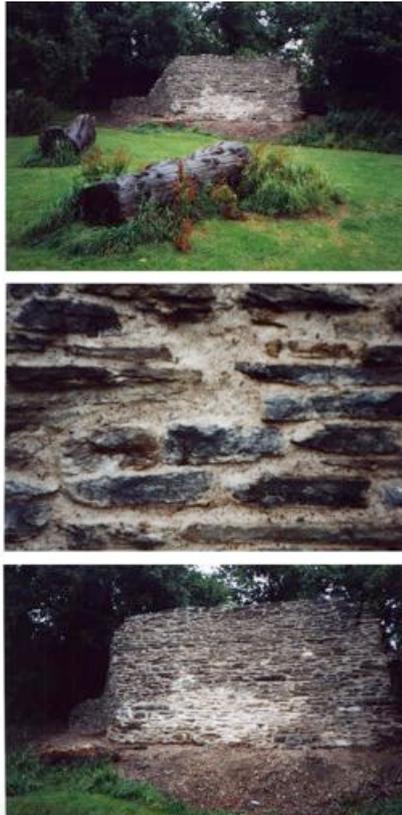
Castle Green
Bishops Castle
Castle Wall
as repaired
17/7/2001.

In this category I am considering the upstanding remains, often of scheduled structures, whether the walls were originally part of a perimeter wall or a building. The integrity of the masonry has to be assured and the optical devices are used to check for voids in the construction. These remains are subject to the similar destabilising factors as the lower garden structures, often progressing through to the criteria used in the chimney assessment section of this paper. They are often of irregular plan and vertical format that may assist or aggravate their ability to resist external forces.

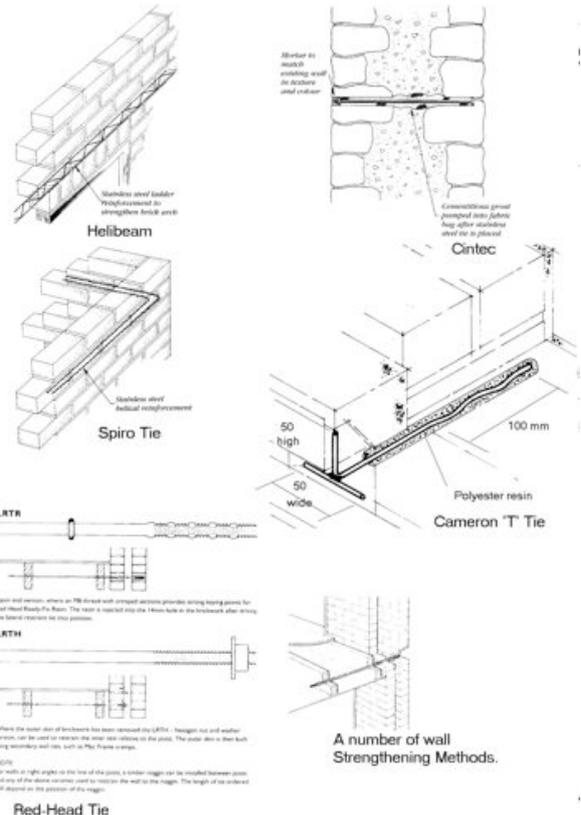
Ties

There are times where there can be the acceptance of an amount of wall de-lamination and tying the looser masonry back together with the aid of mechanical fixing. Internal anchors can be used, after the style of replacement house wall ties, to restrain what could be perceived as two separate leaves. The desire is to enhance the number of headers already within the wall. There are proprietary ties or some can be devised from threaded rod suitably glued to the parting leaves. The intervening void should be packed or grouted to exclude moisture and further frost action.

'Home made ties' can be from stainless drawn rod, threaded bar and/or reinforcement made up into 'staples' the minimum requirements are for 100mm embedment beyond the covering pointing and 200-300 mm to either side of the crack being stitched.

required forces can be calculated but it is the mass that has to be generated and made effective, without the risk of a further force upsetting the calculated balance achieved. A version of a tension buttress that I have seen proposed was the usage of wires, tied down to a mass concrete base or 'pile' formed by a motorised fence post auger. The tension in the wires has to be judged carefully, by the use of strain gauges, so as not to damage the structure further.

Tension buttresses are theoretically possible but awkward to achieve in practice, despite tension being the most efficient method of load transfer. The

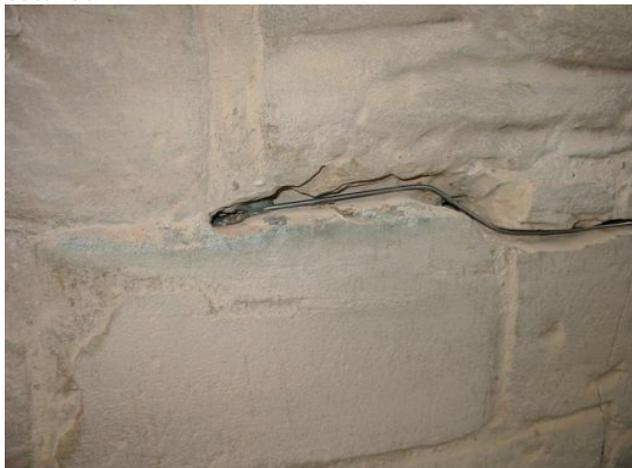
Consolidation by Grouting - Here a degree of ingenuity has to be performed. The wall may be voided as in many cases with a random stone cored wall. The wall is checked for integrity with optical probes and a decision made whether the core is capable of receiving grout.

Grouting is performed using a weakly cementitious lime or PFA based material introduced by either gravity or very low pressure pumping. Small 20mm diameter holes are drilled into the wall where voids have been located or are anticipated.

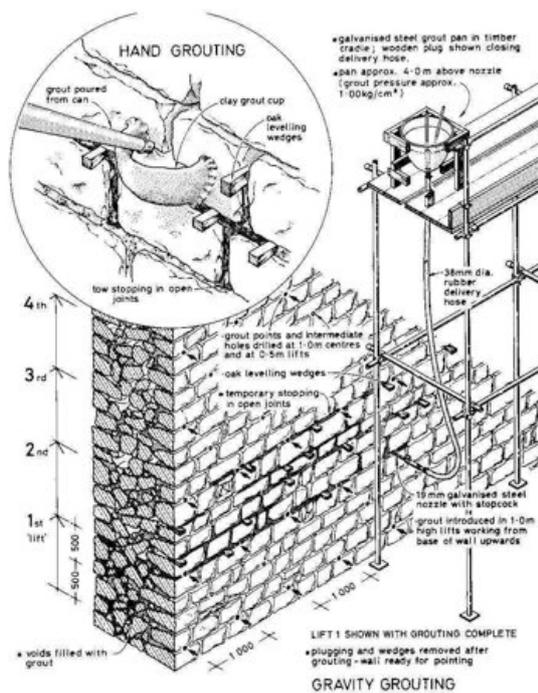
Figure 5

Mixes no stronger than 1:3 lime:sand are considered reasonable for historic work but may not achieve a good set or durability if built in autumn or winter, despite best endeavours at protection. A winter mix may be as strong as 1:2 lime:sand to overcome the curing problem, or a hydraulic lime used but still with suitable weather protection.

Pointing is the process of filling the outer part of the joints between masonry units in a wall, either during the process of building, or to restore full section of the wall when the original material has weathered back from the surface. Compatibility between the main wall mortar and the new pointing is essential. Mortars for reconstruction of walls or any structure should relate to and mimic that with which it was originally constructed. Additionally the prevailing weather during the rebuild period, and the staff used to be carefully considered. Sampling is the best way

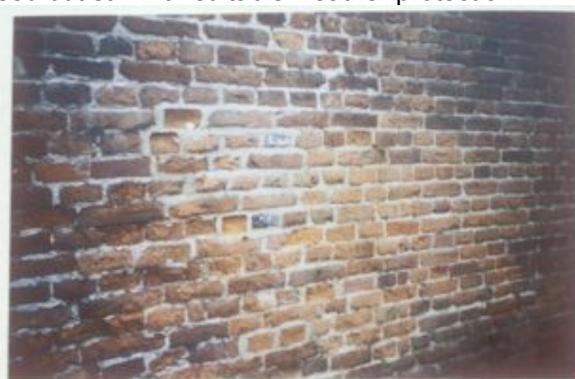
BRICK EROSION DUE TO IMPERVIOUS MORTAR IN A LOCAL AREA.

It should always be remembered that 'hard onto soft' will not work. Often one sees 'new' shallow pointing falling off the front of the joints. This is not only because it was shallow but in application the joint may not have been 'wetted in or cured' properly. Any mortar if cementitious or stronger it has a greater potential for shrinkage and is loosened on initial drying out. Pinch points can be caused with a hard mortar putting stress on the hard fired brick edges.

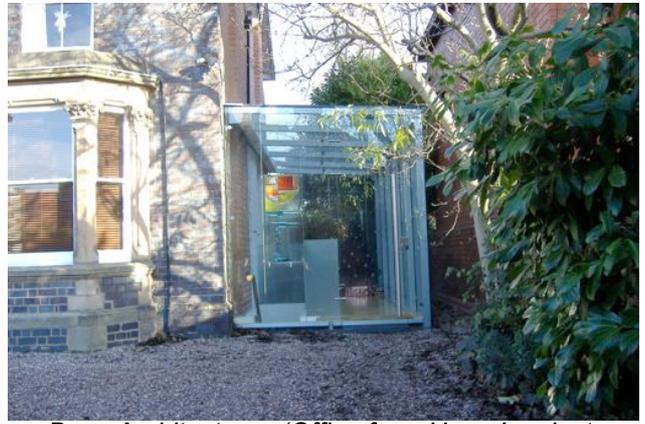
Base Architecture - 'Office from Home' project, Mountfields CA, Shrewsbury. The glazed box with deciduous tree shading

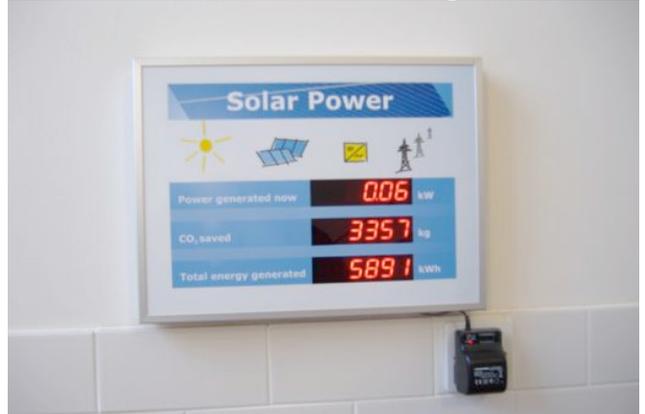
The Pump House, Shrewsbury – solar power output monitor

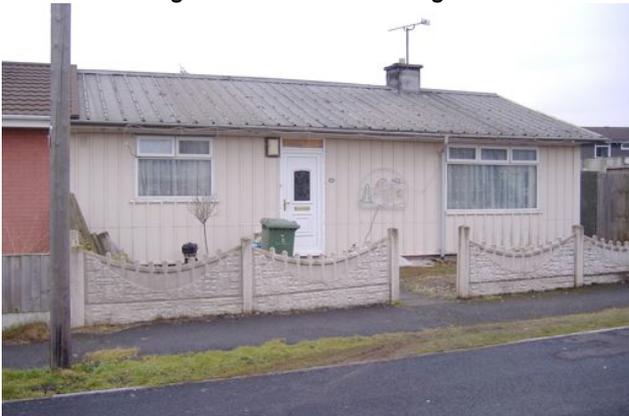
Another Stafford prefab – original roof and cladding, but new windows

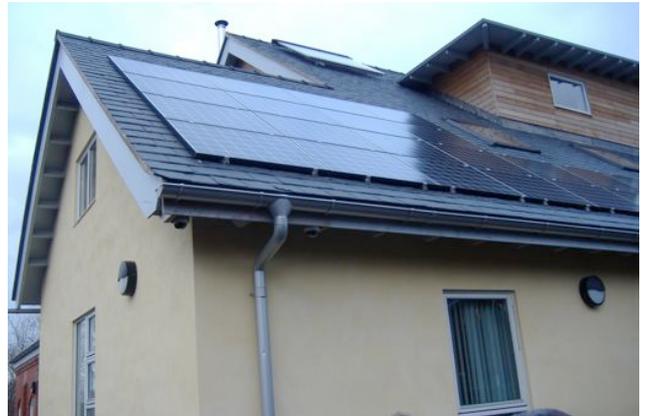
The Pump House – PV panels on roof
